LABORATORY MEASUREMENT OF THE REDUCTION OF TRANSMITTED IMPACT SOUND OF A FLOOR COVERING

Test report ID: T2019-1

LABORATORY MEASUREMENT OF THE REDUCTION OF TRANSMITTED IMPACT SOUND BY FLOOR COVERINGS ON A STANDARD FLOOR

Client: The Tile Warehouse Ltd.

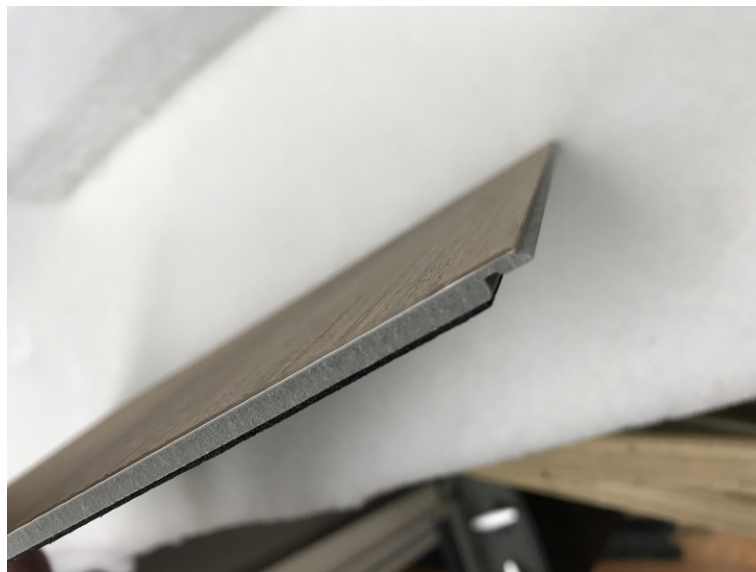
Figure 2.4: Flooring profile
